EFFECT OF FLANGE GEOMETRY ON THE STRENGTH OF BOLTED JOINTS

by G M Pinfold, NCL Stewart Scott Limited, London, UK

Paper presented at CICIND's 42nd meeting, Copenhagen, September 9, 1994

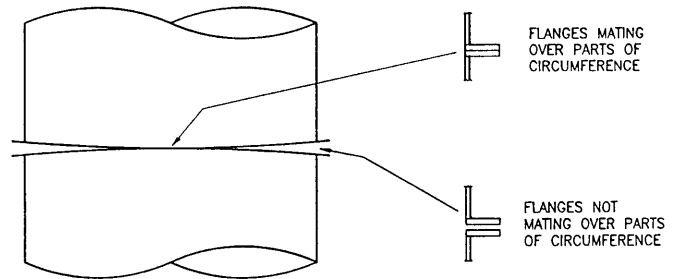
Fig. 2(b)

We have encountered two common types of lack of fit which may occur separately or together. The first is where the flange is not truly normal to the shell as shown in Figure 2(a), but the heels are planar and able to mate. The second is where the flanges, whilst being normal to the shell, do not mate around the circumference as shown in Figure 2(b). The first type often occurs as a result of welding distortion which some manufacturers reduce or eliminate by adding gusset plates. The second type results from failure to match manufacture the pair of flanges forming the joint or from a subsequent change in relative orientation of match manufactured flanges, which for some reason are not planar.

In chimneys we have inspected we have discovered fabrication mismatching gaps of up to 5mm or so.

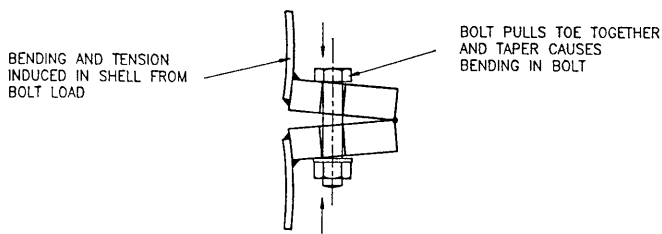
Fig. 3

Figure 3 shows what can happen in non-mating parts of the flange circumference at the various stages of loading. Figure 3(b) illustrates the position after bolt tightening but with no wind load. In Figure 3(c) the load path for wind tension is shown. Because the flanges taper, the bolt seats eccentrically and the tensile force causes bending in the bolts. There is already a force magnification due to bolt eccentricity and the relative areas of bolt and shell; the wind stress in the bolt can be an order higher than that in the shell (by a factor of 30 typically). Thus, in fatigue

terms a relatively modest stress range in the shell becomes highly significant in the bolts. When in compression, if the shell stress is sufficient to overcome the preload induced from the bolt tightening then the joint closes. With repeated tension and compression both the bolts and the shell in the vicinity of the flange become liable to high stress/low cycle fatigue and quickly fail, and/or the bolts become loose.

If the lack of fit is large and the shell/flange combination is stiff it may not be possible even to draw the toes together into contact as was the case in 3(b). Vertical wind stresses in the shell are then transferred through the bolt alone with associated angular movements of the flange and flexing of the shell. The flange movements cause bending of the bolts and both the bolts and the shell can again be liable to high stress/low cycle fatigue failure and/or the bolts loosen.

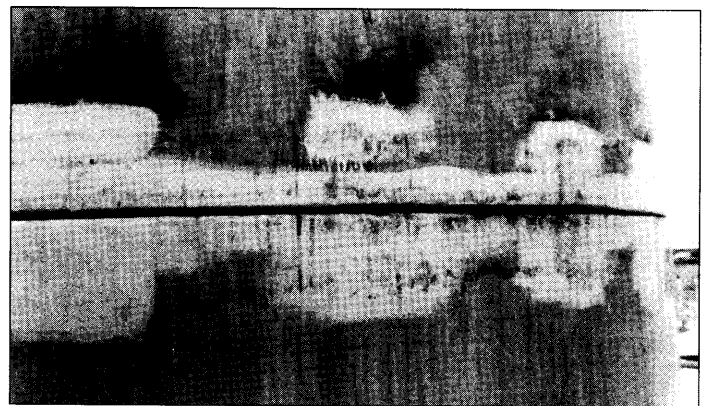
Case A1

Figure A1 shows the flanged joint at the 12m level of a 50m high chimney. Damage was noticed 23 months after construction when bolts failed on opposite sides of the chimney. The bolts were reported to have failed in fatigue and there was cracking (up to 70mm long) in the 8mm steel shell above the joint around the tops of the gussets. There was no cracking discovered in the comparable positions in the 10mm shell below the joint. After bolts had been replaced the toes were in contact but a survey of the heels showed gaps at positions coincident with the bolt failures and the shell cracks. See photograph.

Any opening/closing of the joint would have caused the flanges to rotate about the toes. The gussets would have the effect of increasing the stresses in the shell and concentrating them in the vicinity of the tips of the gussets. It was concluded that the mismatch of the flanges had allowed the bolts to become subject to high fluctuating wind stresses, and the shell to flex in the parts of the perimeter having the gaps between the flanges.

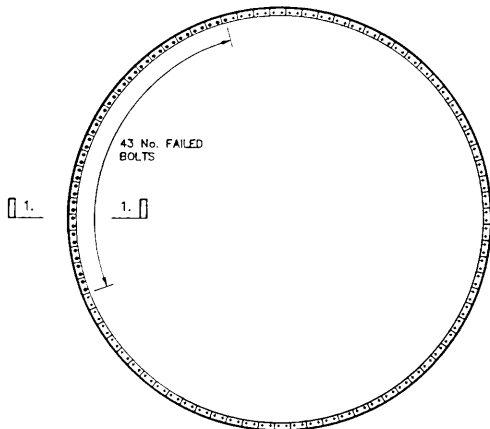
Fig. A3

Figure A3 shows a flanged joint at the 28m level of a 80m tall chimney. Five years after erection and after severe winds (200 year return period wind speed) over one quarter of the bolts of the one joint were found to have failed. The bolts that had actually fractured are reported to have failed by low cycle/high stress fatigue. Some of the bolts tested were found to have shanks too long to permit the tightening torque to tension the bolts against the flanges, leaving the bolts loose.

There was no survey information to establish whether there was any degree of mismatch of the flanges.

It was concluded that the excessive winds allowed the flanges to part resulting in high fluctuating bolt loads, exacerbated by possible lack of pretension in the bolts (and therefore of precompression between the flanges).

OF THE SAMPLE OF FAILED BOLTS TESTED ALL HAD SUFFERED BRITTLE FATIGUE FAILURE DESCRIBED AS LOW CYCLE/HIGH STRESS. NO REPORTED SHELL DAMAGE OR GEOMETRICAL MISMATCH BETWEEN FLANGES

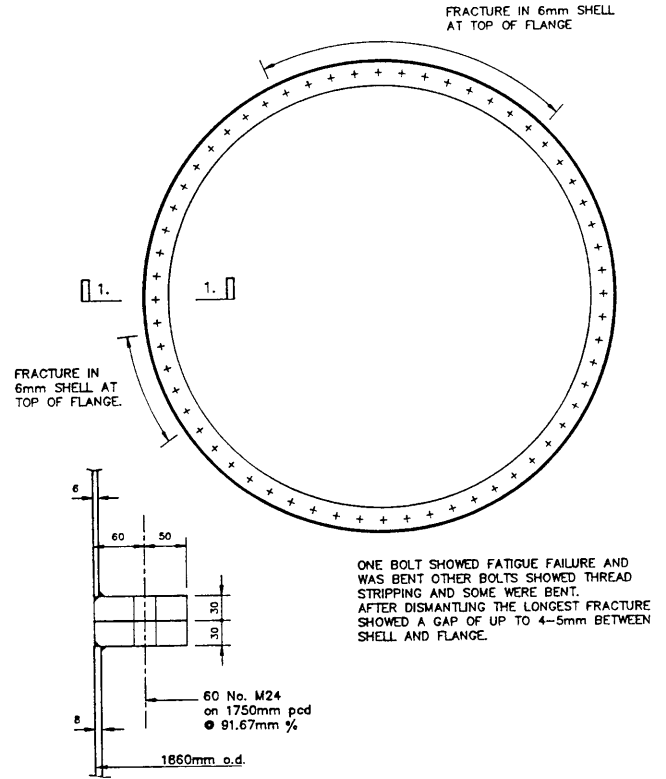
Fig. A4

Figure A4 shows the flanged joint at the 19.8m level of a 30m tall tower. one of over one hundred similar structures at one site. Damage was noticed shortly after erection when cracks appeared at the flange to shell joint as indicated. One bolt is reported to have failed in fatigue and others were bent. Inspection of other completed joints showed some of them to have gaps between the faces over parts of the circumference of up to 5mm. Similar degrees of mismatching were found in the flanges of sections of structures yet to be erected.

It was discovered that the bolt installation had been specified as to be by the part-turn method. This is only suitable where the flanges are initially in contact. Where they are not, the bolts will only draw the faces closer together by a distance corresponding to one third to one half of the pitch of the bolt (in this case by about 1mm), leaving a gap between the flanges and bolts with very little tension in them. It was concluded that failure was due to high fluctuating stresses in shell and bolts due to the gaps between the flanges.

On repair and re-erection the bolts were installed by torquing and the gaps were able to be closed. Other non-failed joints were treated similarly. The degree to which there is residual precompression between the mating surfaces in some areas remains uncertain.
