EFFECT OF FLANGE GEOMETRY ON THE STRENGTH OF BOLTED JOINTS

by G M Pinfold, NCL Stewart Scott Limited, London, UK

Paper presented at CICIND's 42nd meeting, Copenhagen, September 9, 1994

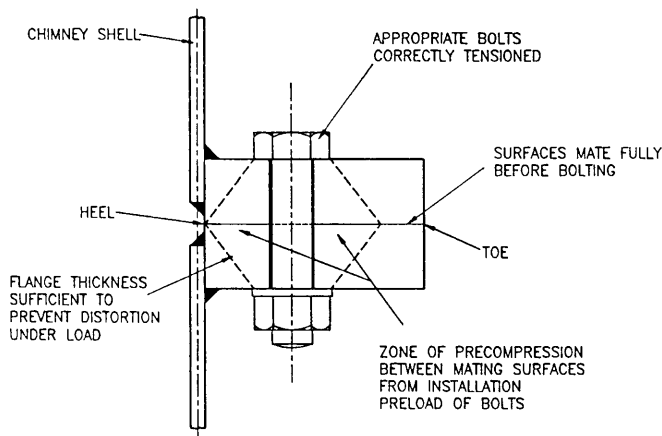
Fig. 1

Figure 1, based on the CICIND model code for steel chimneys (Figure 9.2.1), illustrates some of the desirable features of a flanged joint.

The bolt force is calculated by simple statics assuming that the flanges are on the point of parting at the heel, and forming a 'fulcrum' at the toe. In fact, a properly installed nut and bolt has a pretension greater than its specified safe working load, so that, provided the flange is sufficiently rigid, wind tensions are taken mainly by relief of the precompression between the mating flange faces rather than by an increase in bolt tension. For example an M24 grade 8.8 bolt has a specified safe working tensile load of 99 kN and when installed to the recommended torque has a pretension of approximately 170 kN. Thus if the bolts are designed for safe working load the flanges will not start to part until the applied load is some 1.7 times the design value. Under such conditions the low cycle fatigue life of the bolt is not a consideration.
